# CIVIL AERONAUTICS BOARD

## AIRCRAFT ACCIDENT REPORT

NORTHWEST AIRLINES, INC.,  
LOCKHEED ELECTRA, L-188C, N 137US,  
O'HARE INTERNATIONAL AIRPORT  
CHICAGO, ILLINOIS, SEPTEMBER 17, 1961

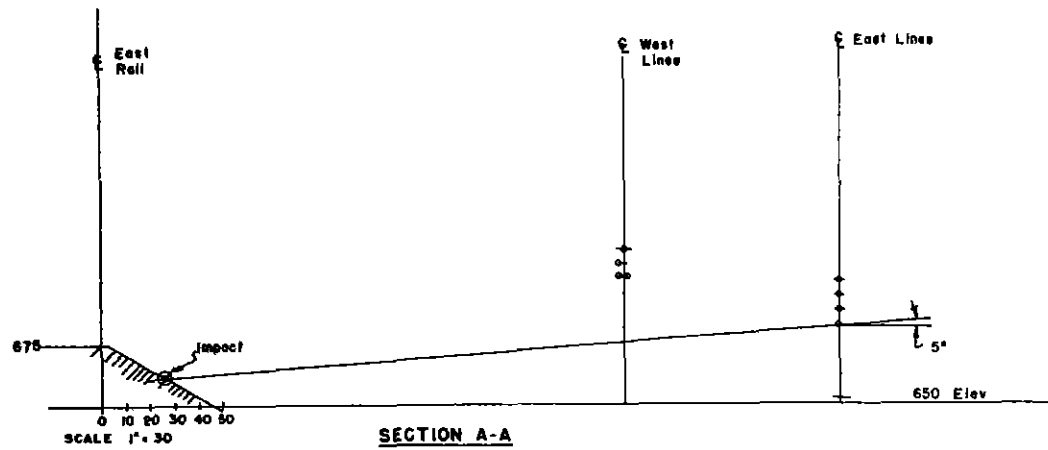
Attachment 1

# ESTIMATED FLIGHT PATH

PREPARED BY CAB OPERATIONS  
GROUP - 9/22/61

Plot traced from aerial photo  
taken 9/17/61
